Big Hole Watershed Committee

Habitat Restoration Projects and Outreach Report

March 2005

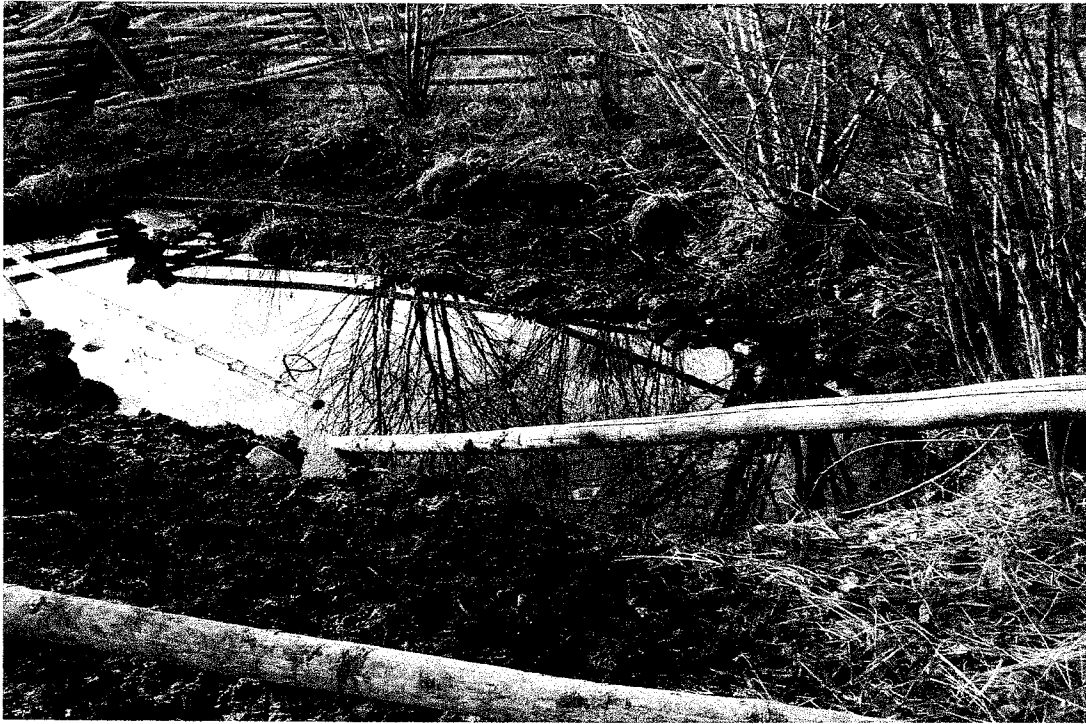
Photo 1. Spring Creek 1, Kalsta Ranch. This spring is the origin of the longest creek (approximately half-a-mile) that flows from west to east. Cattle have trampled the spring and downgradient stream, but would be restricted with riparian fencing under proposed project.

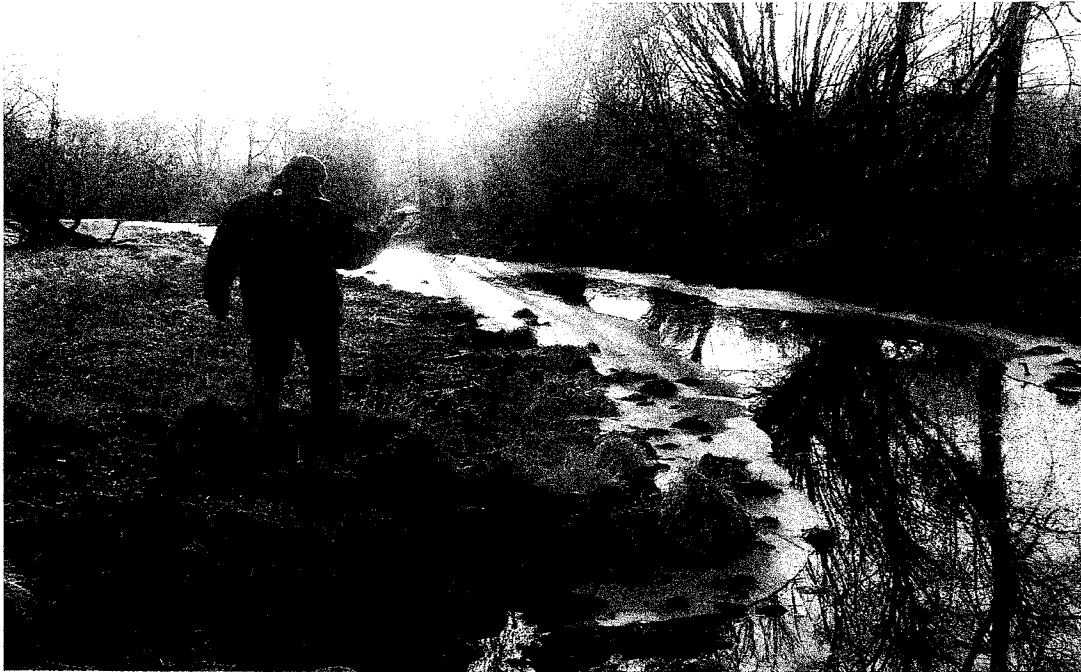
Photo 3. Spring Creek 1. An indicative stretch of Spring Creek 1 downgradient of the spring. Current conditions would be eliminated by rebuilding the stream bottom and banks and restrictive access to livestock through riparian fencing.

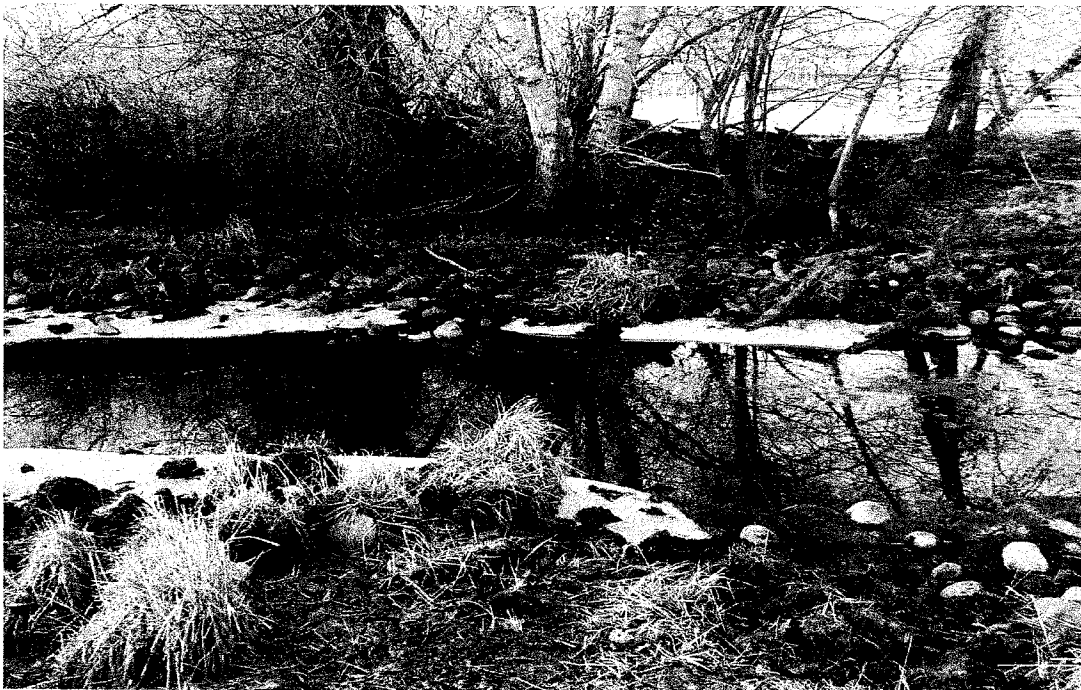
Photo 4. Spring Creek 1. Closer view of indicative stretch of Spring Creek 1 downgradient of the spring.

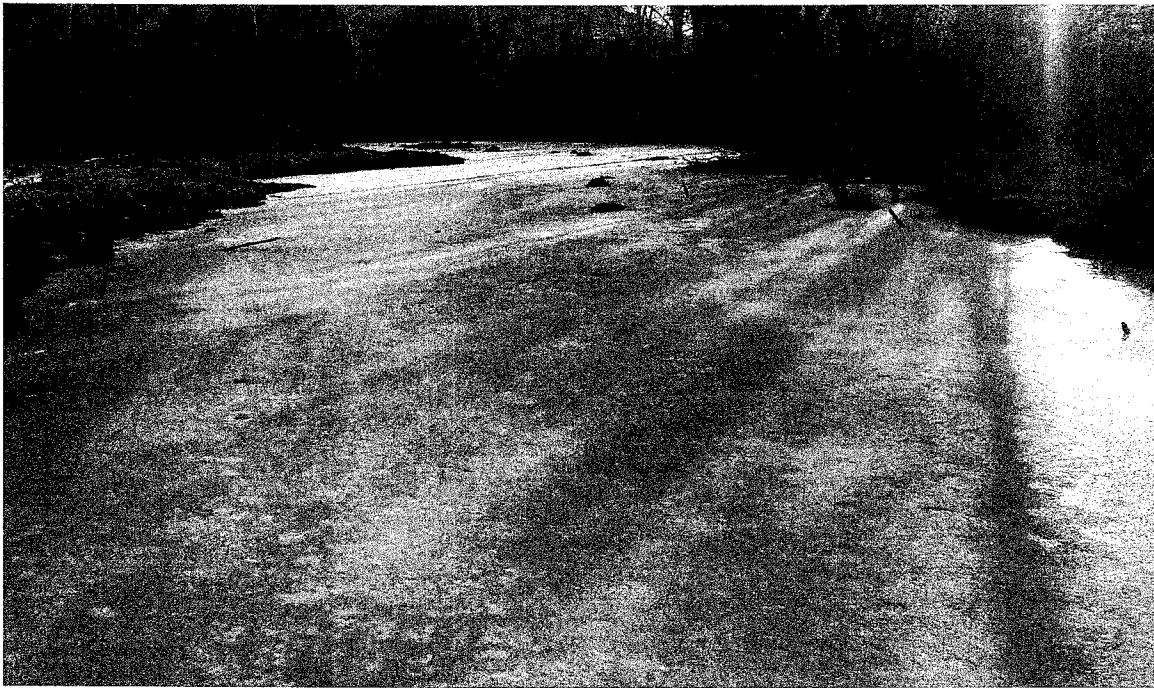
Photo 5. Spring Creek 1. Spring Creek 1 upgradient of a road with a culvert that may need to be up-sized to prevent backflow of the stream.

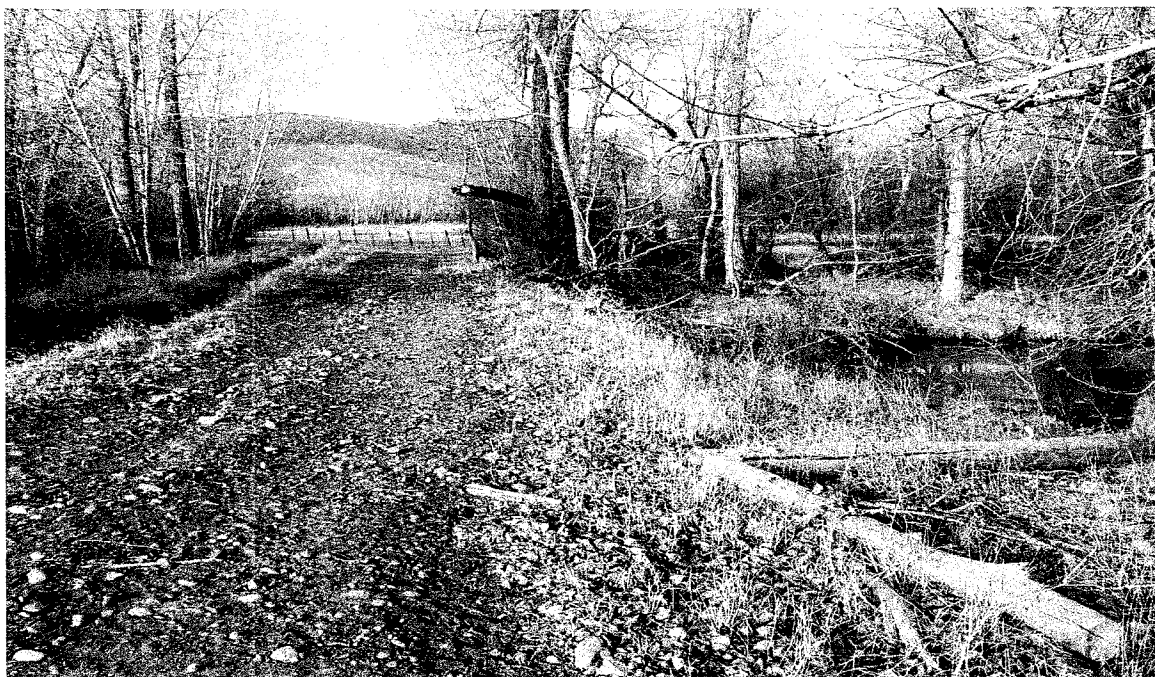
Photo 7. Spring Creek 2, Kalsta Ranch. The road pictured above restricts natural subsurface flow from the river aquifer and Big Hole flood waters from reaching a second spring-fed stream channel located south of Spring Creek 1. Surface flows of Spring Creek 2 begin on the right side of the road and flow north to northwest before joining Spring Creek 1. A culvert or road removal is needed to restore perennial flows to Spring Creek 2.

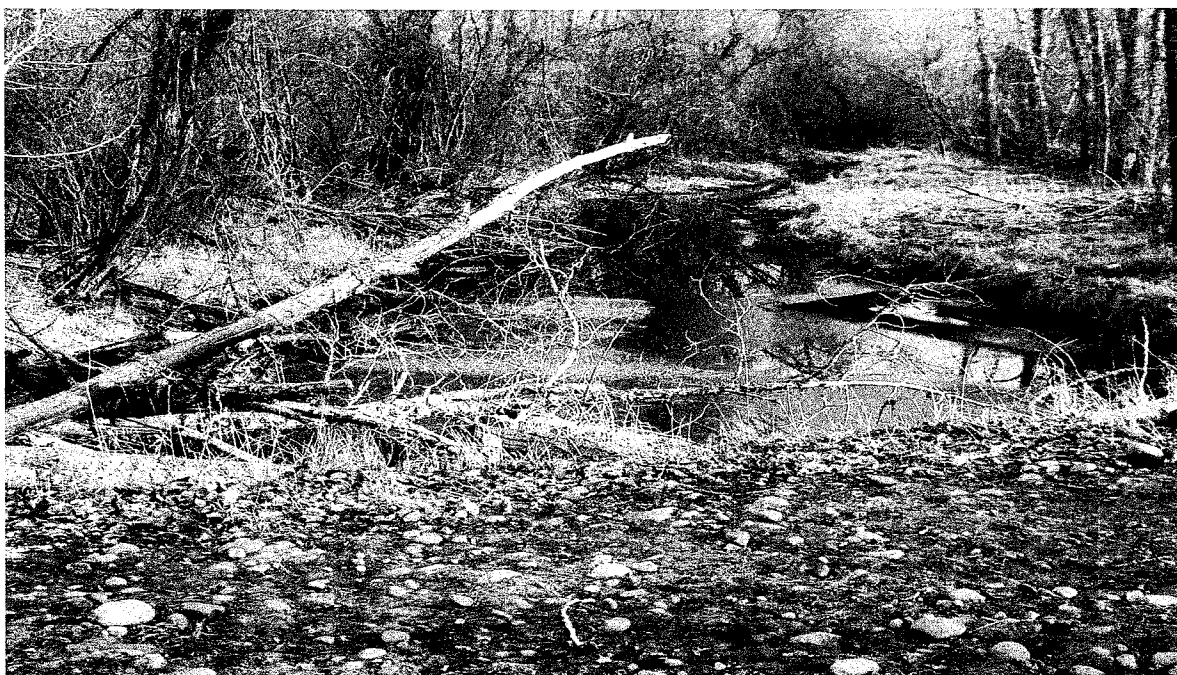
Photo 9. Spring Creek 2. Spring Creek 2 downstream from the road (to the right in Photo 7). Natural features are evident that the stream flowed prior to the road installation. Road removal or installation of a large culvert would be needed in order to restore flows.

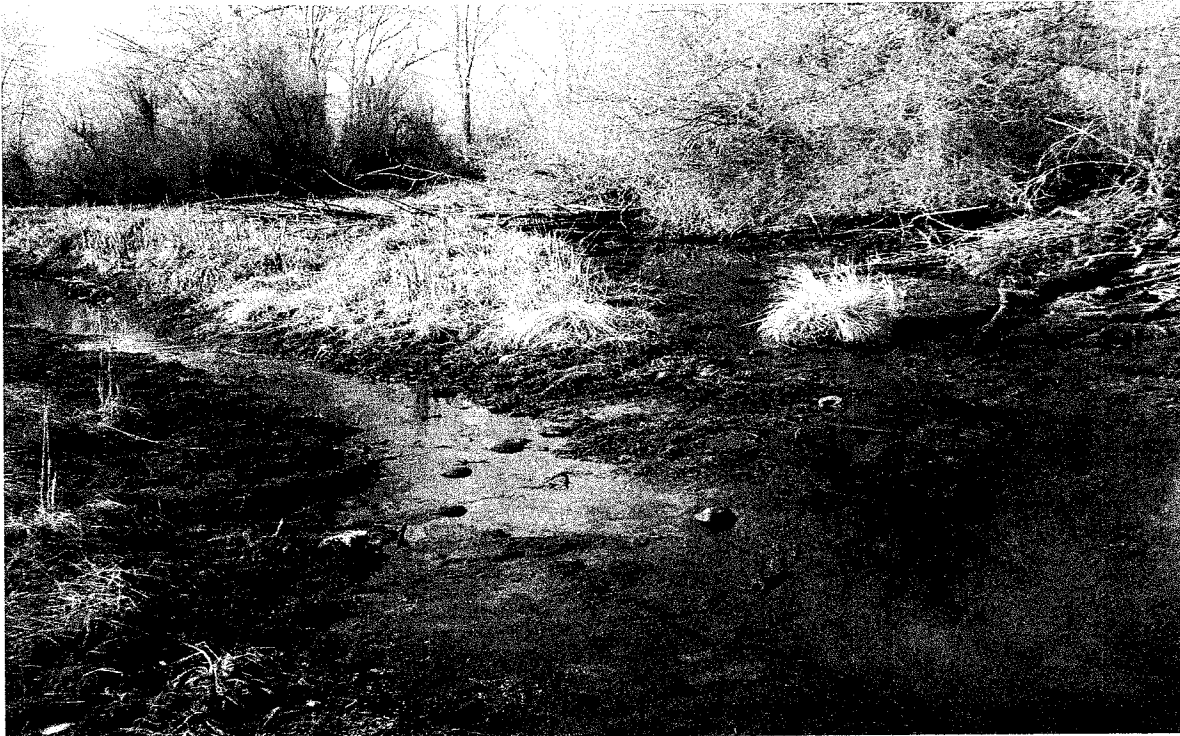
Photo 13. Spring Creek 1 discharge. Spring Creek 1 at its discharge to the Kalsta Slough. Note the build up of silt and debris from upgradient sources.

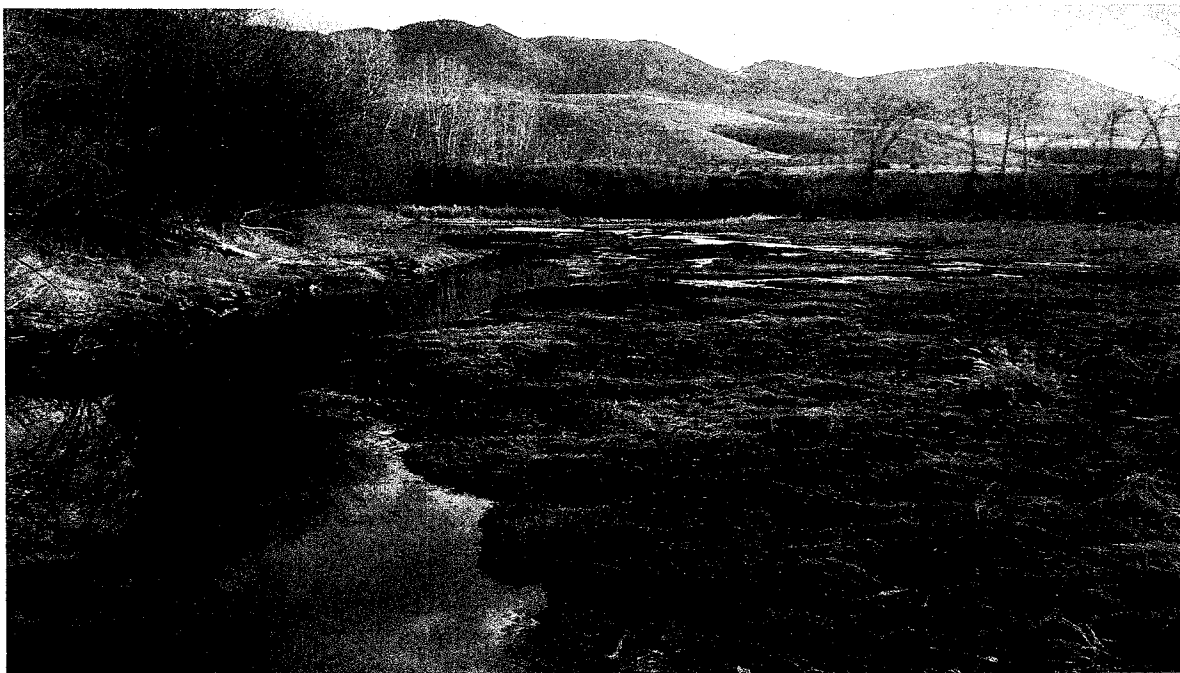
Photo 14. Upper end of Kalsta Slough. Upper end of Kalsta Slough where Spring Creek 1 dumps in. Area to the right is submerged under low flow periods. Restoration to a trout-sustaining fishery would require extensive dredging of built-up sediments.

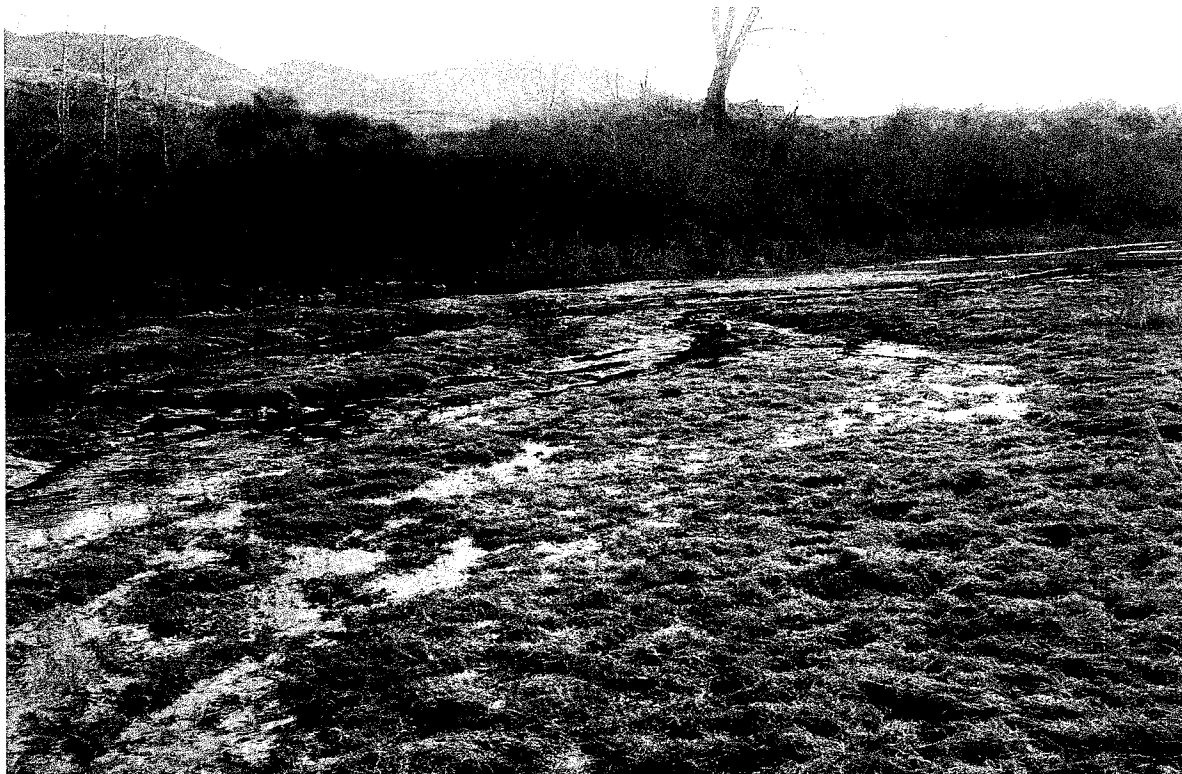
Photo 15. Middle section of Kalsta Slough. A view south at the middle section of Kalsta Slough. Cattails on the right in the photo give an indication of normal-to-high water pool.

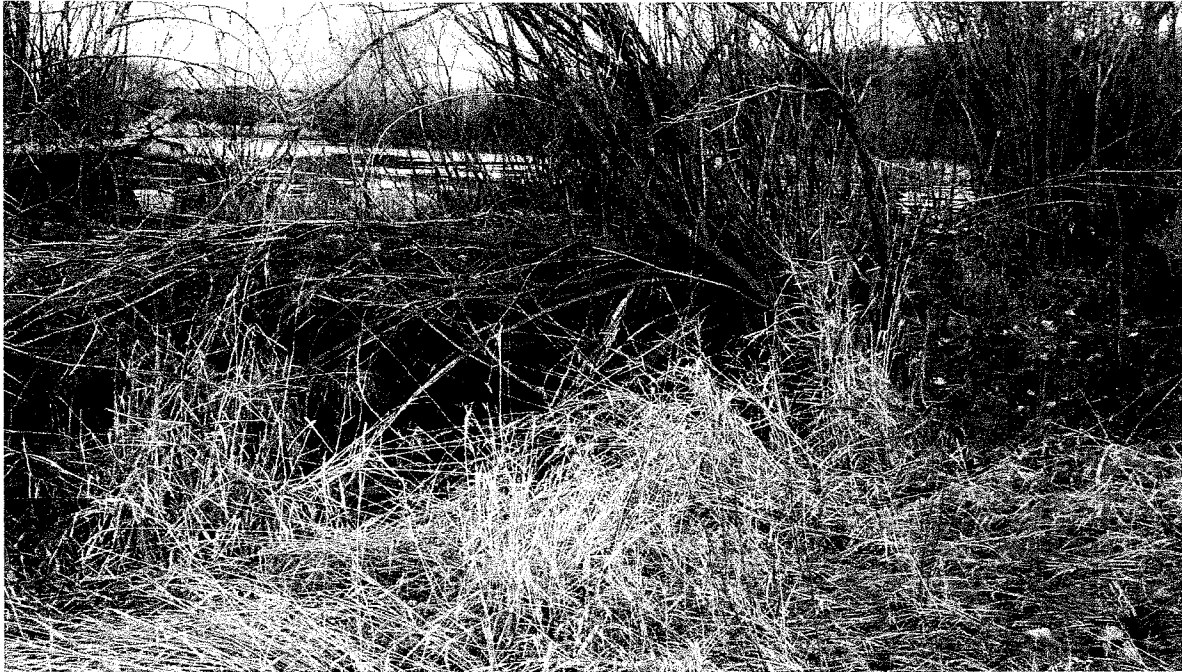
Photo 21. Outlet culvert of Kalsta Slough. Buried in the brush is the outlet culvert to the Kalsta Slough from the easternmost channel. Culvert needs to be removed and/or replaced.

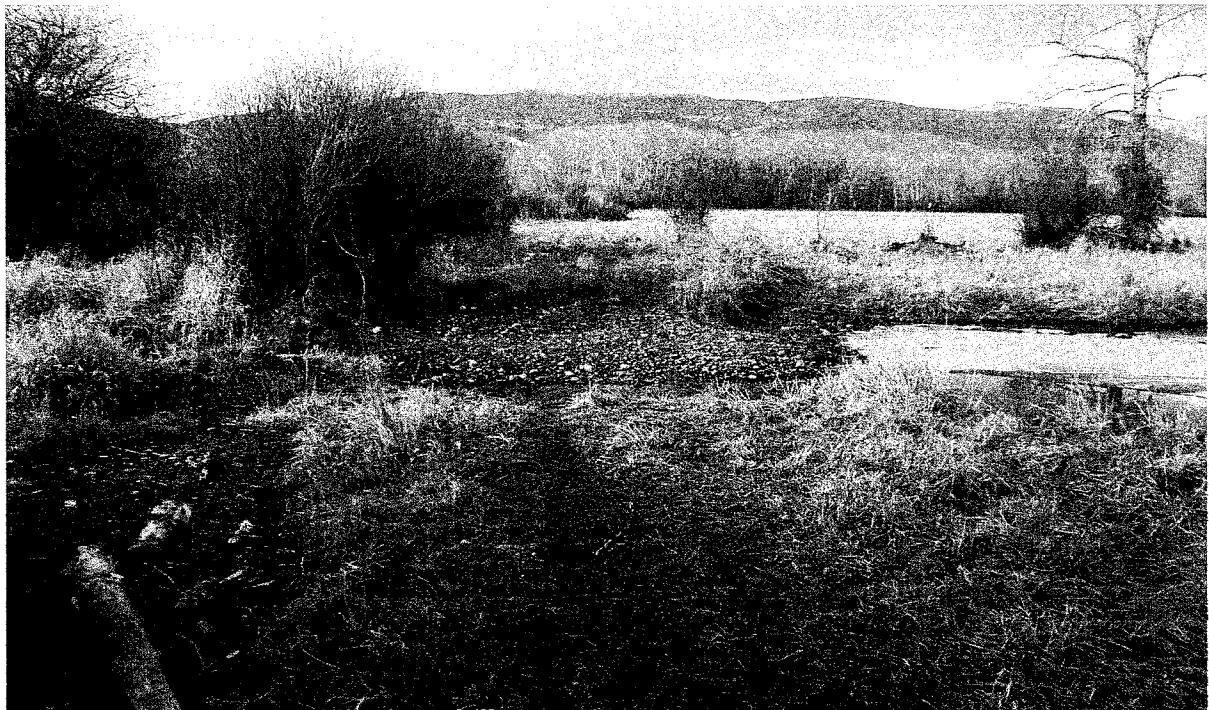
Photo 22. Dike at Kalsta Slough outlet. Looking west across a dike at the outlet of Kalsta Slough. Visible channel is the natural outflow and the culvert channel passes through the ground closest to the bottom of the frame.

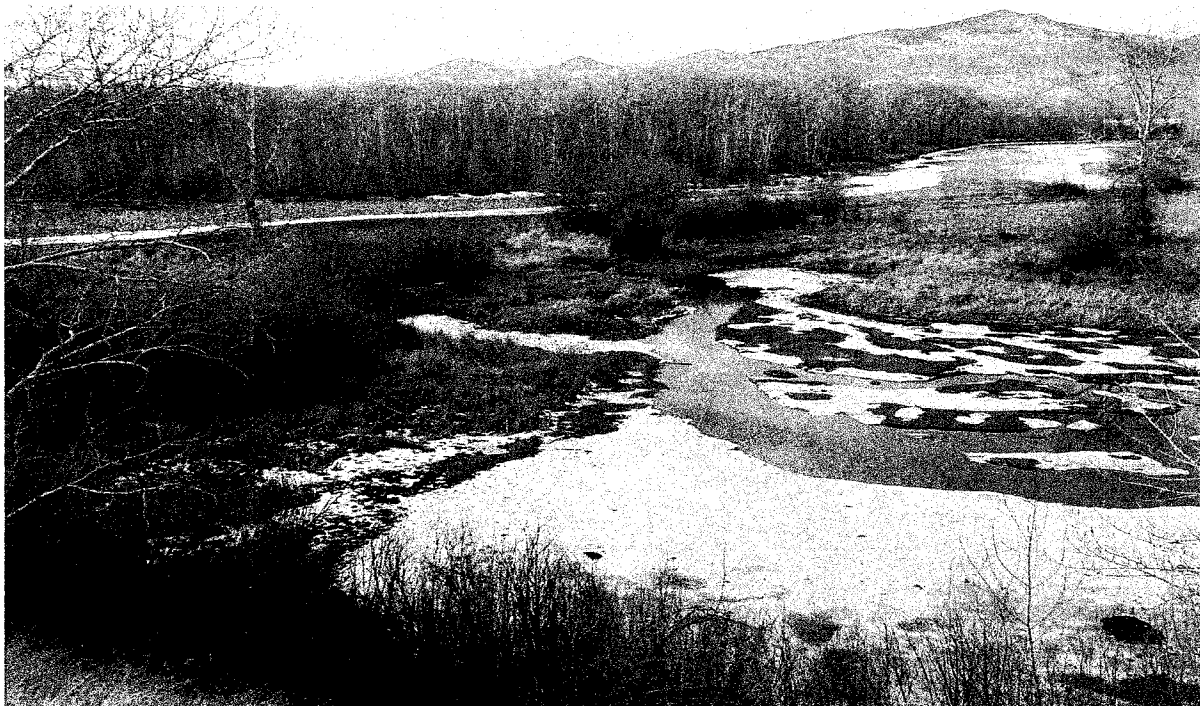
Photo 23. Kalsta Slough outlet. Southwest view of the Kalsta Slough outlet. Natural outflow channel is on the right and culvert channel is on the left.

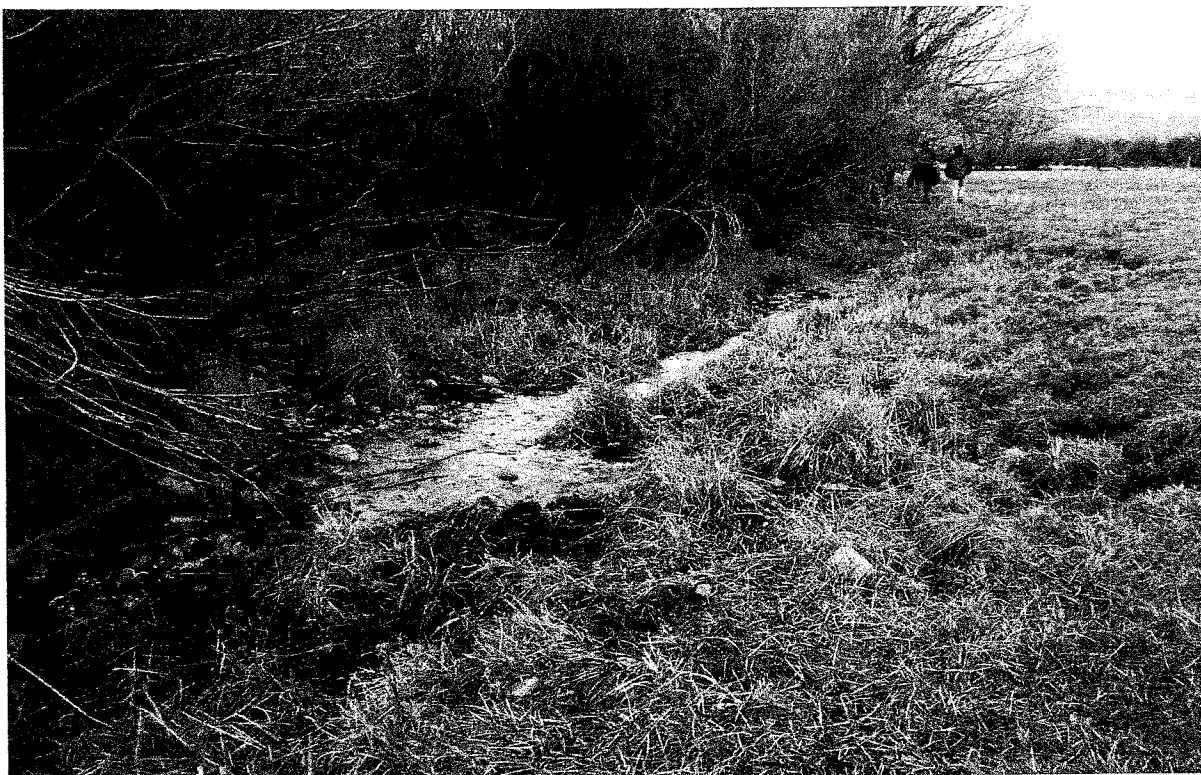
Photo 27. Spring Creek 3. Section of Spring Creek 3 upgradient of the wetland area as it flows along the western edge of a pasture to the north of Kalsta Slough. Stream would be redefined, reconstructed and livestock access restricted with riparian fencing.

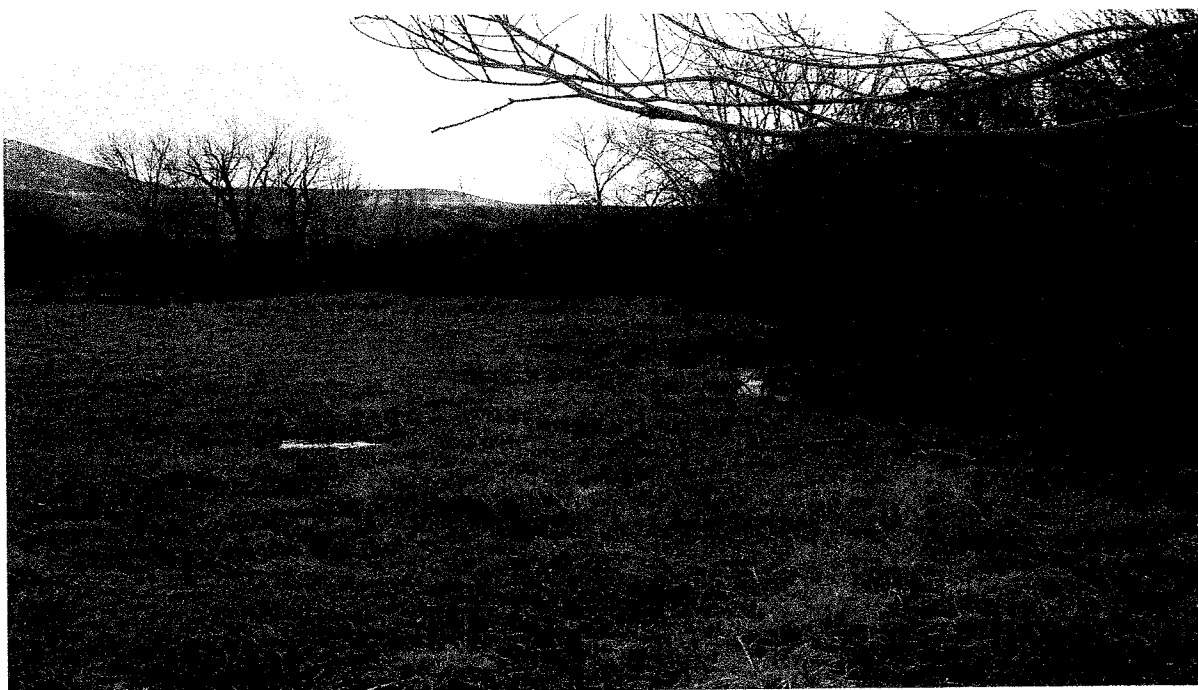
Photo 28. Spring Creek 3. View of Spring Creek 3 looking downstream of Photo 27. Culvert inlet to Kalsta Slough appears on the upper left of photo in front of the cottonwoods.

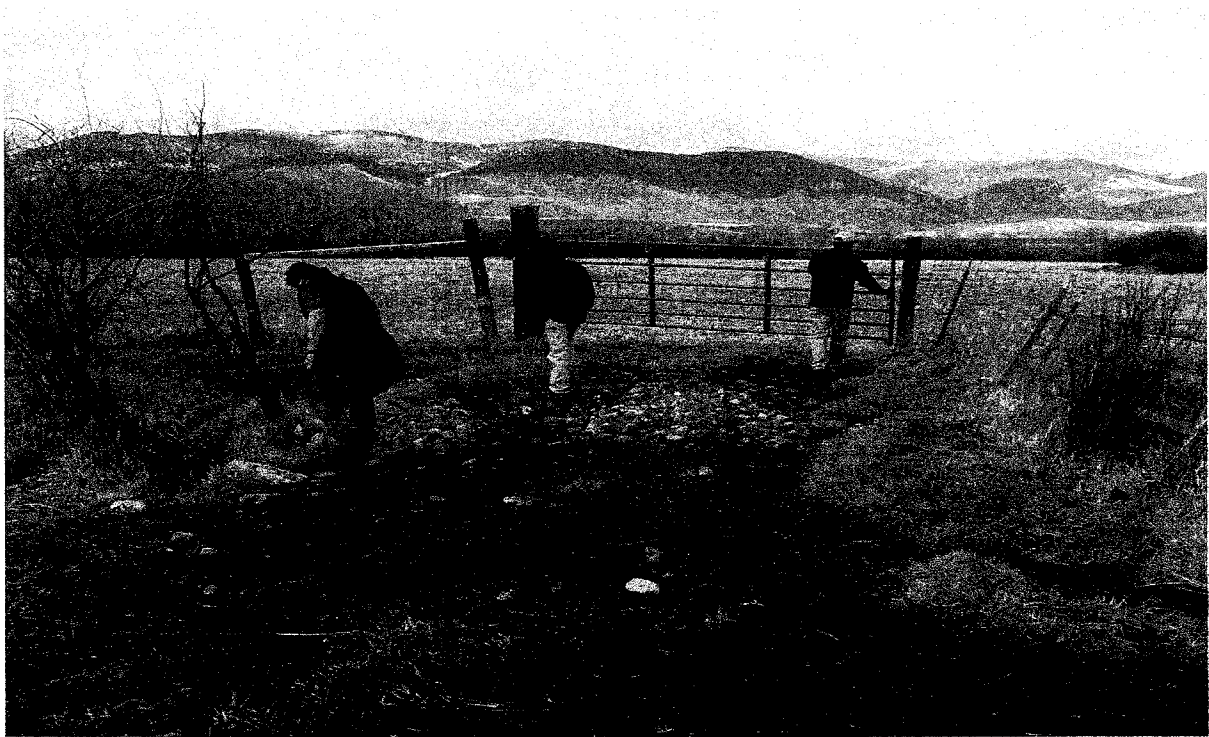
Photo 29. Spring Creek 3, culvert 2. A second culvert is installed at the northern end of the pasture to take flow from Spring Creek 3 beneath the road in the photo. Pending restoration of the stream, a much larger culvert would need to be installed.

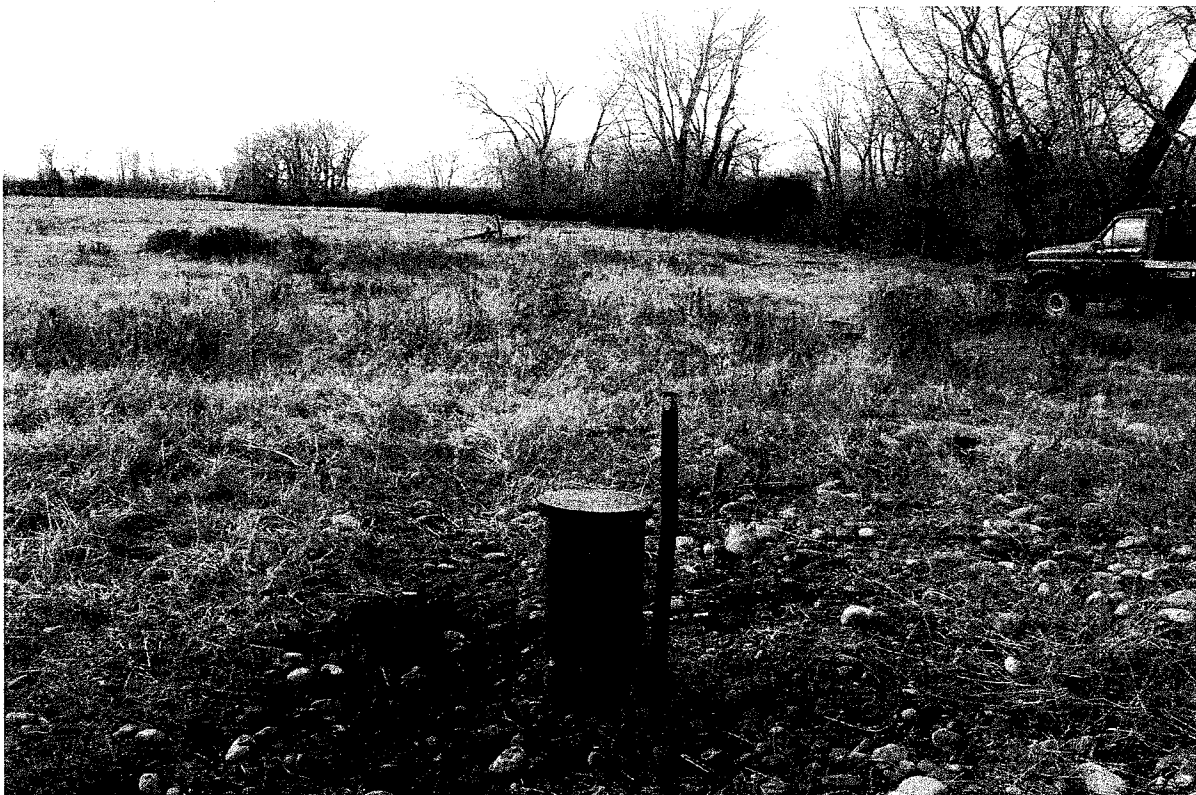
Photo 31. Stock well, Kalsta Ranch. This well was installed in a pasture to serve as an alternate water supply for livestock watering, but has no power source. The Kalsta Ranch would like assistance in developing a power source to the well to provide an off-stream watering source for its livestock.
